# Manhole Inspection Summary

Manhole # S35U\_\_011MH

Insp Date: **2/13/08 1:58 PM**

**Location** Address: **s.hanover st**

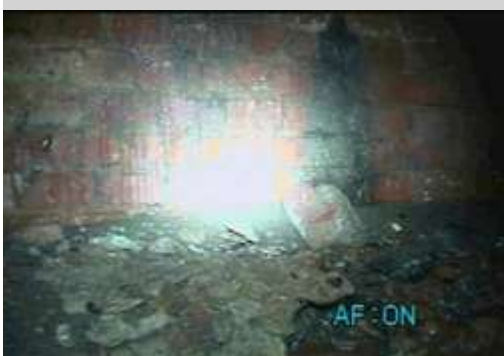
Defect 1

bench debris

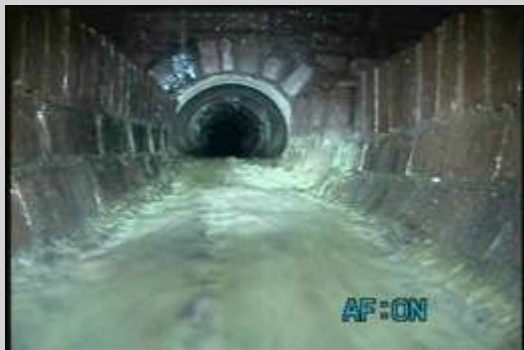
12 O'Clock Outflow

15 in. Circular Gravity Sewer  
Pipe Out @ 12 O'Clock

Pipe Material: **Clay** ☐ Pipe Lined

Invert Depth: **14.30** (ft.) Flow Characteristics: **Fast**

Deposits: ☒ None ☐ Mud ☐ Sludge ☐ Debris ☐ Grease

Infiltration: **None** Pipe Seal Cond: **Unknown**

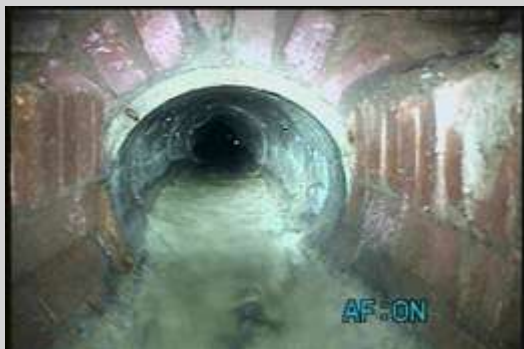
6 O'Clock Inflow

15 in. Circular Gravity Sewer  
Pipe In @ 6 O'Clock

Pipe Material: **Clay** ☐ Pipe Lined

Invert Depth: **14.20** (ft.) Flow Characteristics: **Fast**

Deposits: ☒ None ☐ Mud ☐ Sludge ☐ Debris ☐ Grease

Infiltration: **None** Pipe Seal Cond: **Unknown**
